### PIT5605A Rattle Noise from 60 /40 Rear Seat

Brand:	Model:	Model Years:	VIN:		Engine:	Transmissions:
			from	to		
Chevrolet	Colorado	2015 - 2019	All	All	All	All
GMC	Canyon	2015 - 2019	All	All	All	All

Involved Region or Country:	North America
Additional RPO/s:	AJ2
Condition:	Rattle noise from the rear 60/40 seat
Cause:	Misalignment of the seat back latch

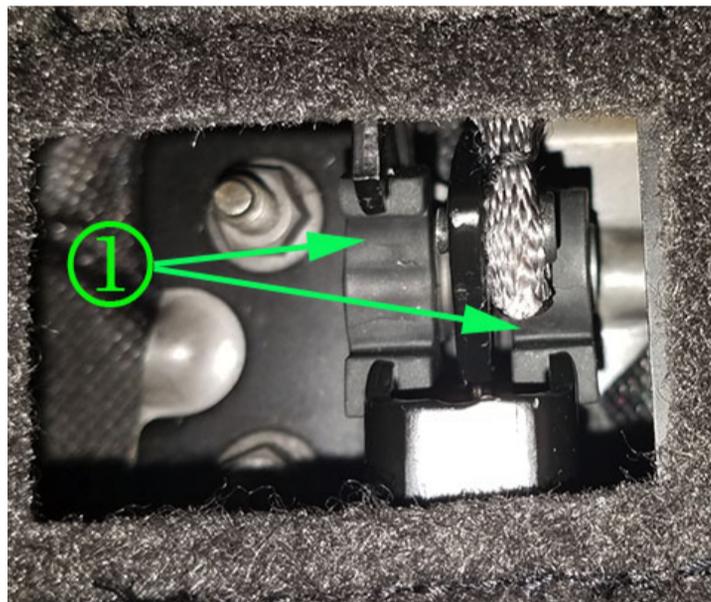
Inspect the alignment of the bumpers in the latch in relation to the striker. (Illustration 1 below.)

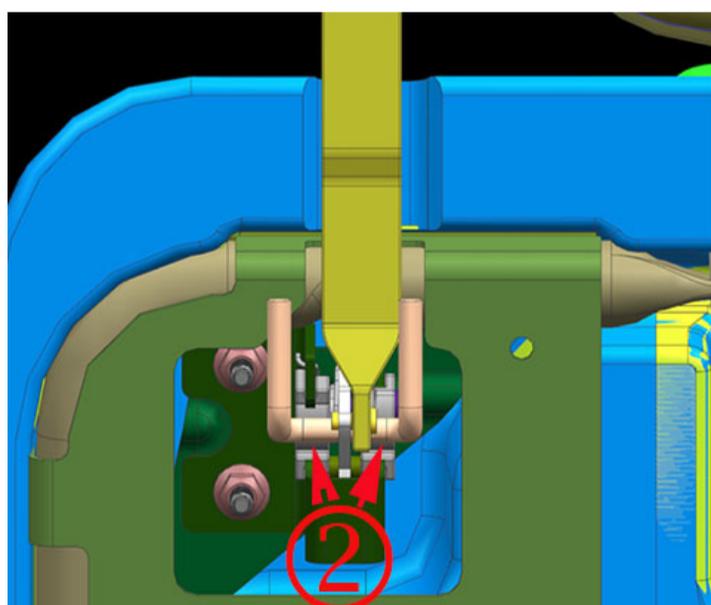
Illustration #2 below shows both bumpers engaged .

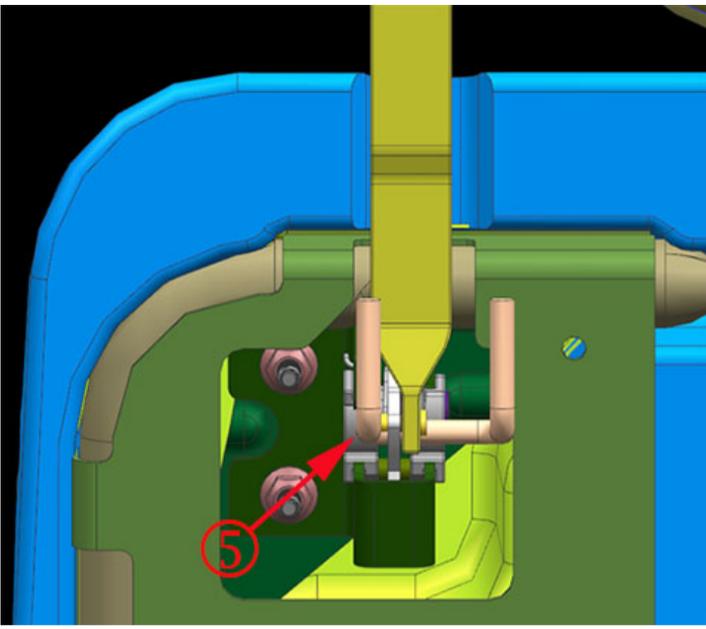
Illustration #3 shows the latch aligned too far right , only one bumper engaged.

**To align the striker to the insulators , loosen the nuts on the studs left and right shown below and move the seat left or right until centered.**

Once aligned retorque the nuts on the studs to 45 Nm (33 lbs ft) and verify repair.

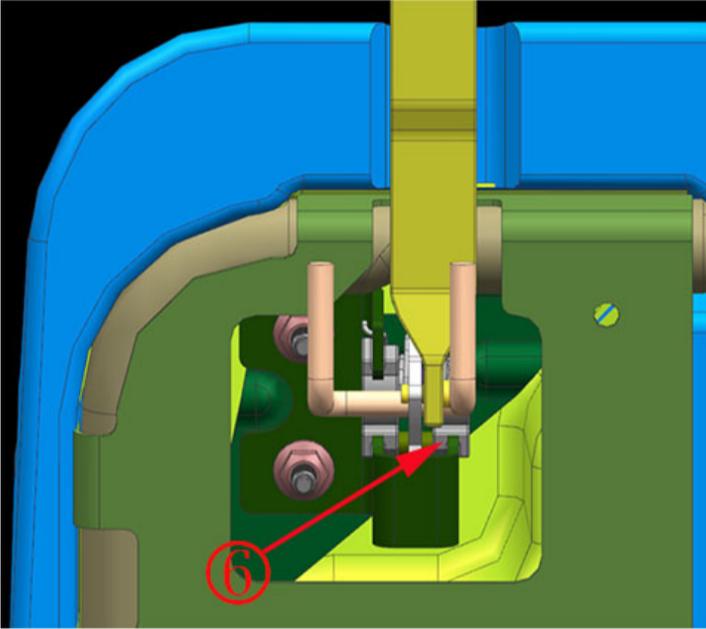
**Illustration #4 shows latch aligned too far left , only one bumper engaged.**
